# Manhole Inspection Summary

Manhole # S31WW\_006MH

Insp Date: **5/30/07 10:28 PM**

**Location** Address: **200 WYMAN PARK DR**

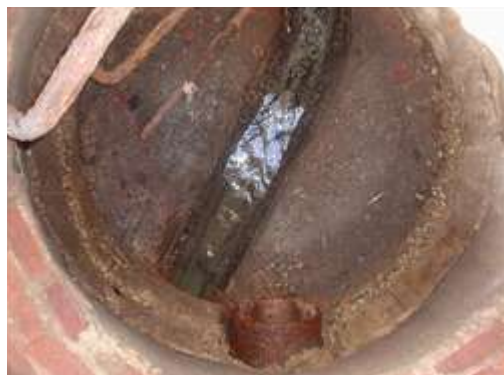
Top View

Corroded steps. Bench debris.

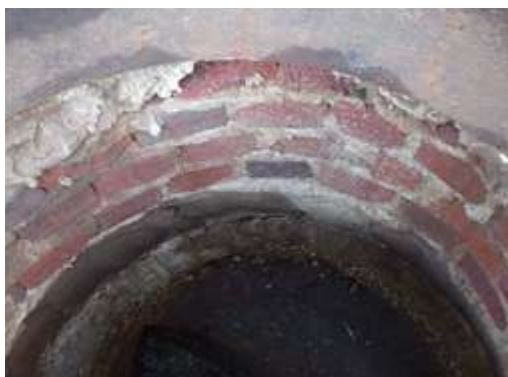
Defect

Adjustment deterioration and infiltration. Corbel cracks and infiltration. Barrel infiltration.

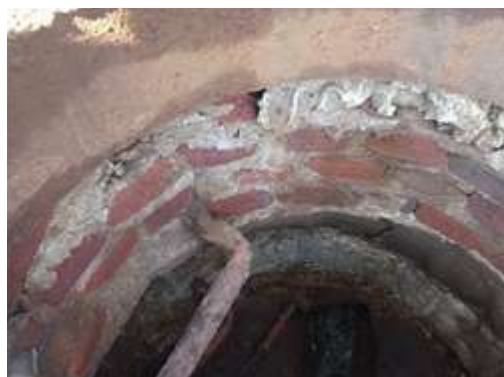
Defect

Frame leaks. Adjustment deterioration and infiltration. Corbel cracks and infiltration. Barrel infiltration - other side.

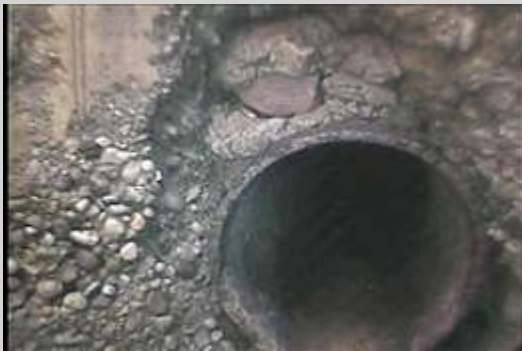
### 8 in. Circular Gravity Sewer Pipe In @ 6 O'Clock

Barrel deterioration and infiltration.

Infiltration: **Evidence**

Pipe Seal Cond: **Broken**
